Department of Water Resources

BULLETIN NO. 167

PILOT LEVEE
MAINTENANCE STUDY
Sacramento-San Joaquin Delta

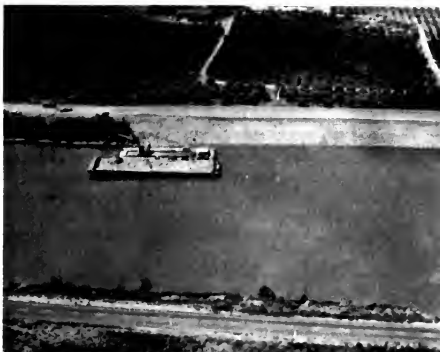
*Barge placing rip-rap on
newly reconstructed levee
for flood control*

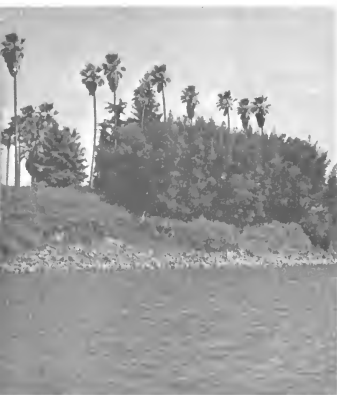
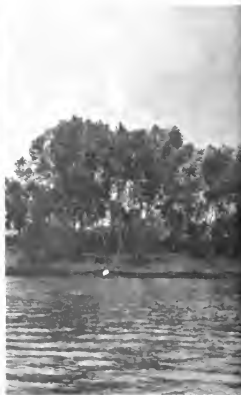
Examples of the wide variation in levee appearance

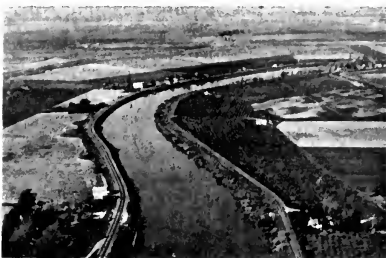
Ryde test site

This site, near the town of Ryde on the left bank of the Sacramento River, is owned and maintained by local interests.

The levee and berm in this area were recently reconstructed and have little undergrowth and no large trees. A 3,000-foot section of levee and berm was used to conduct the various tests.

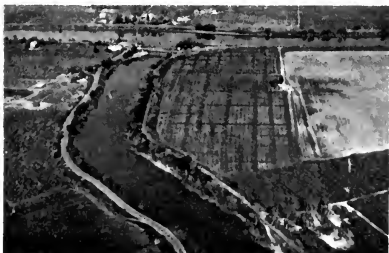
Steamboat Slough test site

This test site lies along both banks of Steamboat Slough, from its junction with the Sacramento River to a point approximately 3,000 feet downstream. There are no berms on either bank; however, dense undergrowth and a large number of trees cover the levee slopes.

The area is accessible by water and road and is used extensively for recreation. There are two small sandy beaches on the left bank and one on the right bank. This section of the slough is extremely popular with cruiser boaters, who tie up for extended periods of time.

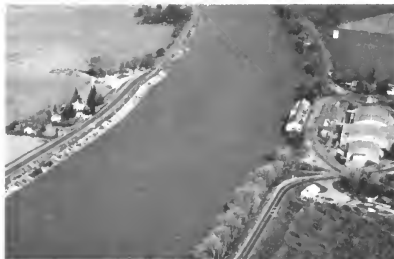
The Hood test site is on the right bank of the Sacramento River opposite the town of Hood. A 400-foot section of levee, recently reconstructed and covered with quarry rock, was used as the test area.

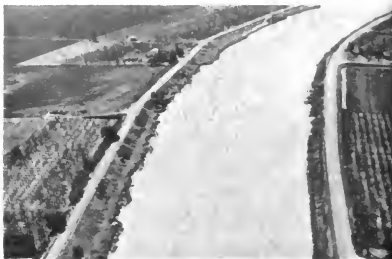
The Isleton test site is on the left bank of the Sacramento River about 2 miles upstream from the town of Isleton.

A section of levee and berm approximately 1 mile long was used to conduct the various tests. This site exhibited a varying range of hydraulic, levee, and vegetative conditions and was selected for the final phase of field testing.

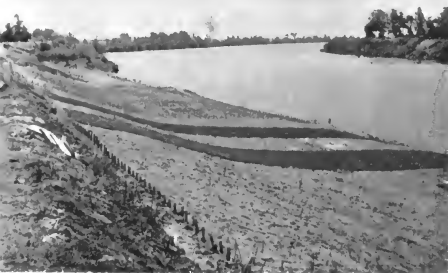
Ground cover adaptation plots at the Ryde test site

Plantings at the test sites were accomplished in the spring and fall of 1964 and in the spring of 1965. Of the 15 species planted under irrigation during the spring seasons, six became well established and grew vigorously. These six were: coastal bermuda, creeping wild-rye, Tifway bermuda sod and stolons, and Tifgreen bermuda sod and stolons. Other species which showed promise for berm and levee slope stabilization were kikuyu grass and matgrass. The remaining species ranged from partial stands to complete failures.

The nine species of fall plantings, which generally grow well in cooler weather, developed good initial stands; however, without water the following year, they failed to develop.

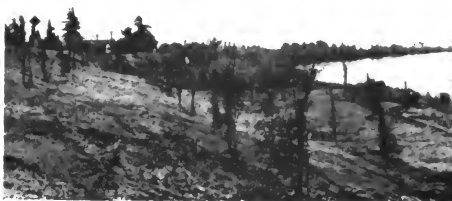
Tree adaptation test at the Ryde test site

Tree Adaptation. In June 1964, a tree adaptation test was started at the Ryde test site. Based on recommendations made by the U.S.D.A. Soil Conservation Service, the following 10 species of 5-year stock trees were selected for

The trees were watered only during the initial year of establishment to test their ability to survive without constant irrigation. In general, the trees on the waterward slope of the levee failed to survive, while those planted on the berm closer to the water adapted very well to the new environment.

On the waterward slope of the levee, the red ironbark and the purple plum demonstrated the greatest ability to survive. The Arizona ash, trident maple, and the beefwood indicated only partial adaptation; all the other trees tested failed to survive.

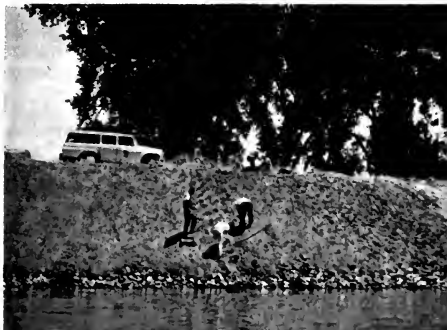
Experiment on the esthetic treatment of revetment at the Garcia Bend test site

*Cobblerack revetment
hand-placed around
existing trees*

Plantings Over Rip-Rap. At the Garcia Bend test site, a 300-foot section of berm was cleared of all vegetation, resloped to 2:1, and covered with cobble-rock revetment in June 1963. One year later, 250 tons of fill material were spread to a depth of 6 inches over the cobblerock. Three separate plots of kikuyu grass, coastal bermuda, and creeping wildrye were planted on the fill material to stabilize the soil.

The plants, irrigated periodically throughout the remainder of the summer, survived in the area above the normal summer water level and prevented the soil from being washed away the following winter. The following spring, native vegetation began to creep into the test plots. Such vegetation, when maintained in the normal course of flood-control maintenance, would add considerably to the esthetic value of the levee.

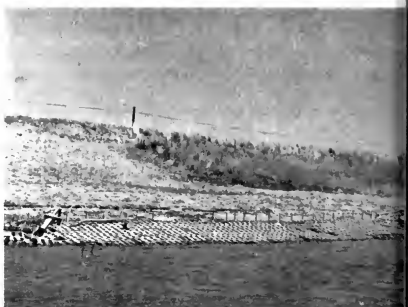
Installation of specially built concrete block revetment

Shortly after the blocks were installed, the continuity of the mat was broken by undermining at certain locations. The blocks were not fully effective in controlling erosion in the tidal fluctuation zone. Also, the majority of the plantings failed to propagate through the voids in the tidal zone.
